Technical Bulletin

Setting the Standard for Food Safety and Pest Management Solutions

January 2020

Have it, Manage it

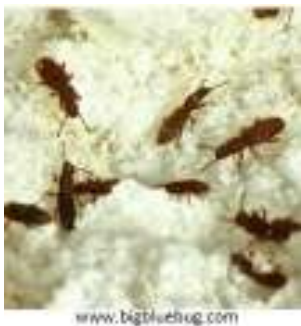
The Sawtoothed Grain Beetle

Order: Coleoptera **Subfamily:** Silvanidae **Genus:** *Oryzaephilus* **Species:** *O. surinamensis*

The sawtoothed grain beetle is a major pest of stored food products. It is brown in color and only about 2.5 to 3 mm long. With a flat body and six tiny projections on each side, just behind the head, it is easily identifiable. These projections give the beetle its name. It helps to use a hand-lens or magnifying glass to see them.

This beetle does not infest whole grain. Its flat body allows it to enter tiny cracks and infest broken kernels. It feeds on cereal, flour, pet food and birdseeds and is also known to feed on nuts, spices, drugs, chocolate and tobacco.

The female beetle deposits eggs in cracks in food or on ground food, like flour. When the eggs hatch, the larvae feed and grow. In ideal conditions, the entire life cycle, from egg to mature adult, takes about 8 weeks. There can be several generations per year. If not controlled.

Control is best accomplished through cleaning and sanitation to break the lifecycle. The application of an appropriate insecticide is the final step. The application should be made into cracks and crevices after all attractive food sources are removed.

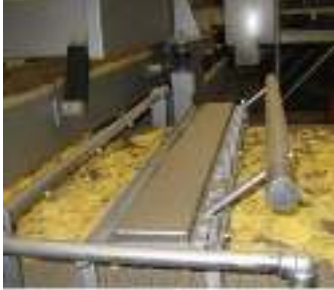
Courtesy of: www.ortez.com

While walking the line and inspecting, the consultant noted a large rare earth magnet across the top of a conveyor, and another, further down the line on the underside of a transfer chute, both within twenty-five feet of each other. This was an odd discovery as the consultant had never seen any logs for the inspection of the magnets and these were not included as process preventive controls on the food safety plan. When asked about the magnets, the QA Manager stated "they came with the line". The team was unaware that these are foreign material removal devices and should be monitored. Additionally, the team (including maintenance personnel) were under the impression that most of their equipment is stainless steel and non-magnetic; this is only a partial truth.

Once the magnet was accessible and could safely be inspected the inspection team noted a thick layer of metal fragments and slivers, identical to the ones consumers reported finding in the products they were consuming. The layer of metal was so thick that pieces were connected to each other and hanging like stalactites which could fall from products contacting the ends or the simple vibration of the machinery. The facility uses metal detectors on some lines and x-ray machines on others. The fragments were too small and thin to be detected by the x-ray due to the settings of the units and the metal detectors were simply not catching these. Both units were recalibrated to ensure detection in the future.

The magnets were cleaned, the source of the fragments identified and corrected. QA Team placed the magnets on the weekly cleaning schedule. In addition, logs were created for inspecting the magnets at shift change. The magnets were also added to the food safety plan and designated as process preventive controls. After the shelf life of the product ran its course the complaint ceased.
